## **HOW COPPER & COPPER ALLOY SURFACE APPEARANCES EVOLVE**

## INTRODUCTION

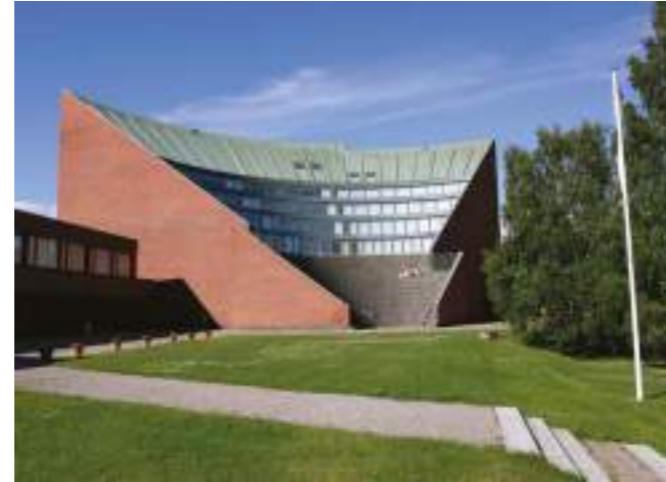
1

Photo 1: Naturally patinated surface of the **Auditorium of the University of Technology**, Espoo, Finland (built: 1949–66), architect: **Alvar Aalto**. The copper covered amphitheatre-like structure contains the main auditoriums, while its exterior can be used for plays and other activities.

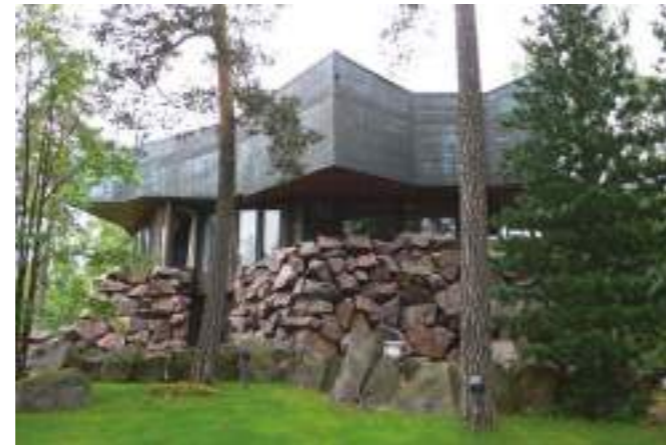
2

Photo 2: Weathered façade of **Dipoli conference centre**, Espoo, Finland. Designed by architects **Reima and Raili Pietilä** and completed in 1966. The key example building of organic architecture uses extensively materials from Finnish nature, such as pine wood, copper, and natural rocks.

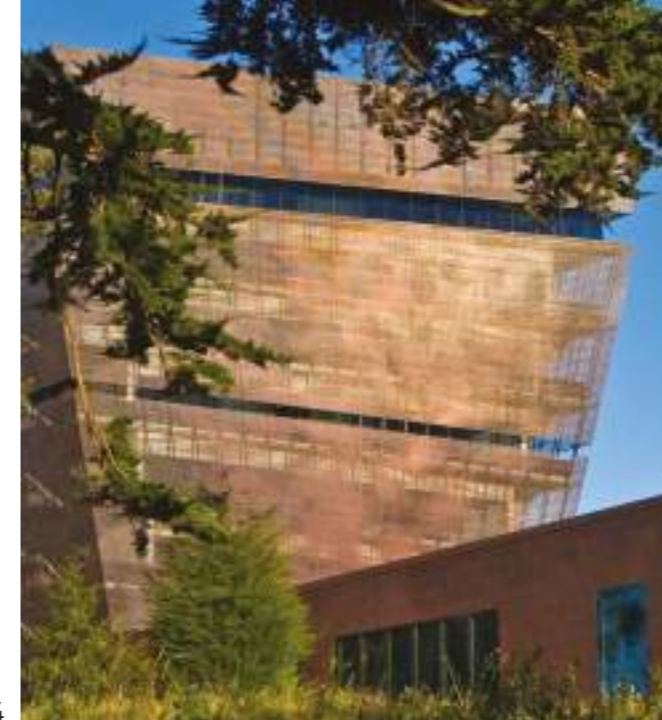
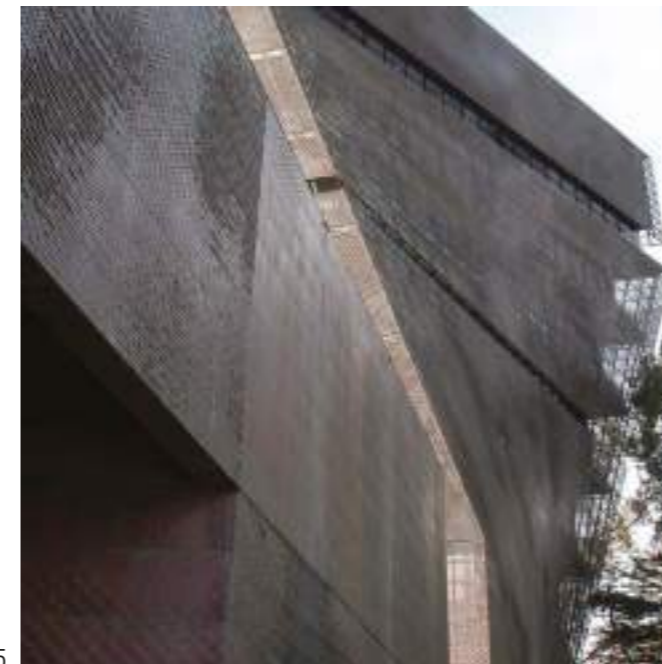
Photo 4, 5: **de Young Museum**, San Francisco, designed by **Herzog & de Meuron**, opened on October 15, 2005. The embossing and perforation is intended to remind us of light filtering through treetops. In this way, the outer cladding of the building corresponds intensively with the surrounding park landscape and the luscious stock of Golden Gate Park's trees, like an abstract work of art. Photo 4 taken Feb. 2006, photo 5 in Feb. 2015.

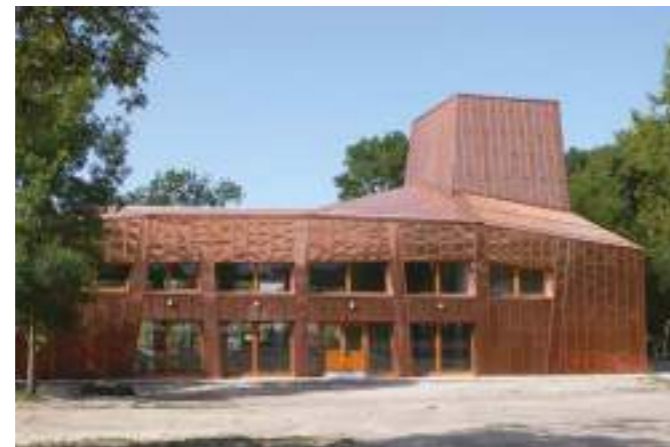
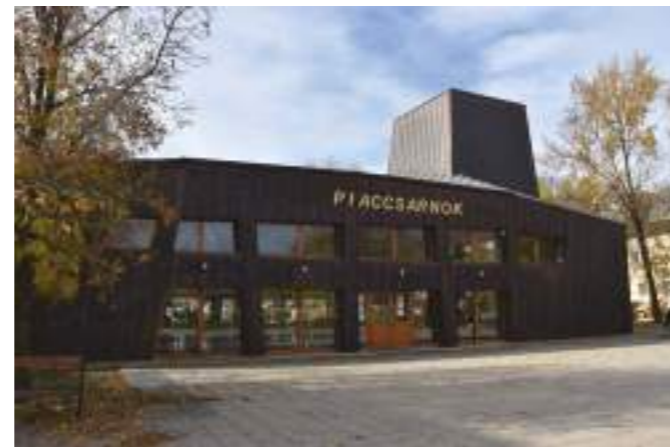
6, 7

Photo 6, 7:  
Dabas, Hungary  
Market Hall  
Architect: Kiss Járomi Építésziroda  
Copper Product: Copper  
Completion year: 2011  
Photos: ECI  
Photos taken 05.2011 and 11.2016 (weathered)

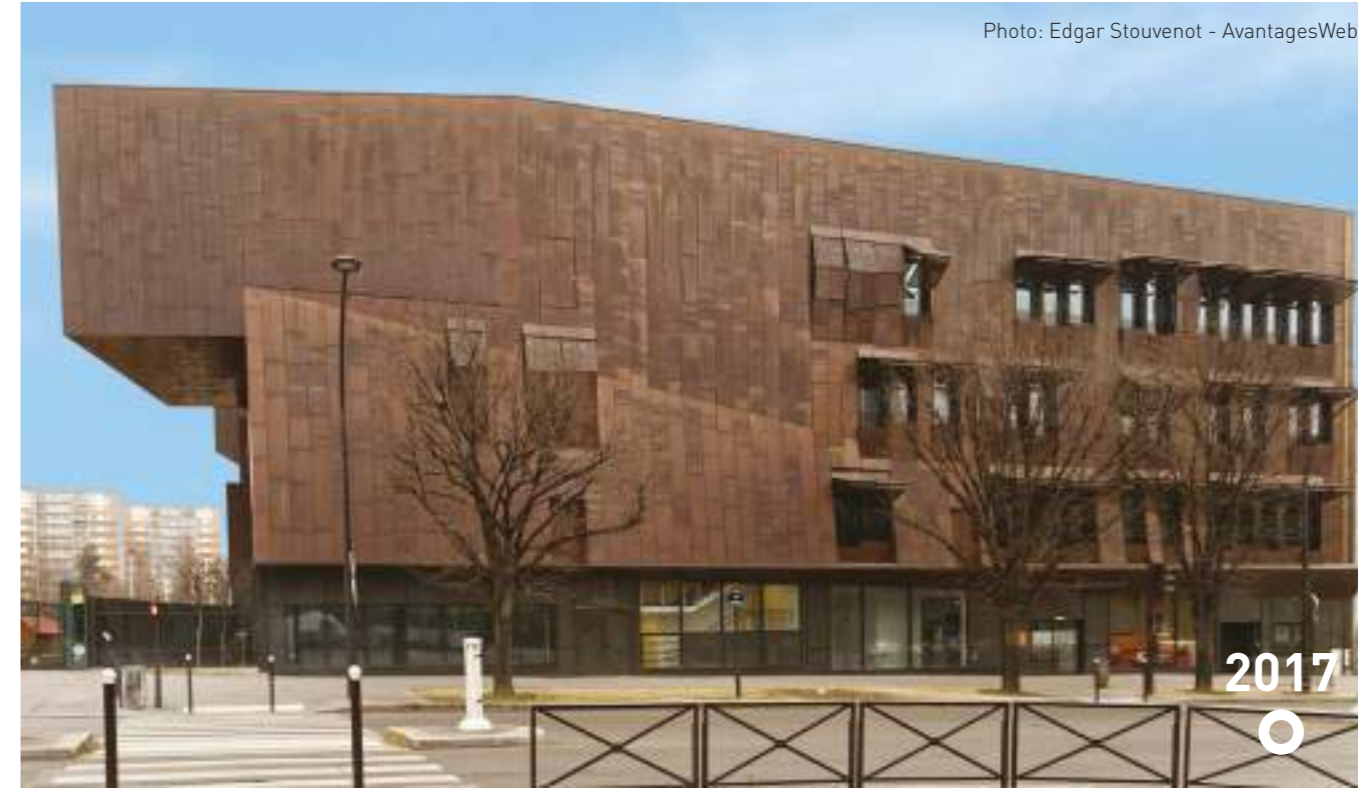
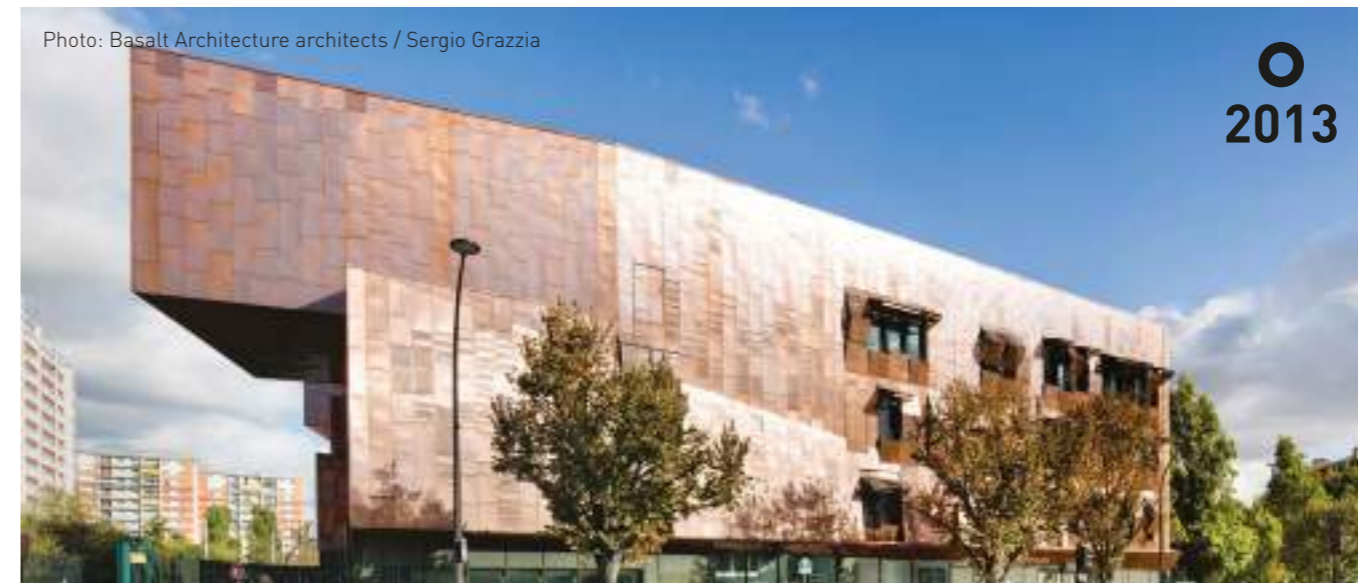
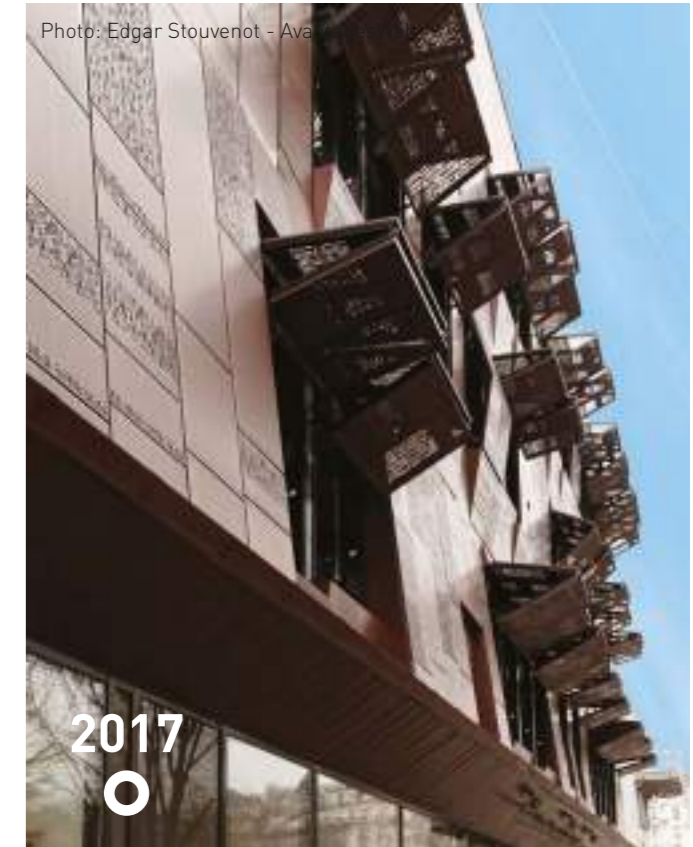
- Copper**  
 Within a few days of exposure to the atmosphere surface begins to oxidise, changing its colour to chestnut brown which gradually darkens over several years and later may become a typical green patina.

- Brass**  
 An alloy of copper and zinc. The original shiny surface changes through from initial matting gradually to a greenish-brown that further develops to greyish brown then dark brown/anthracite colours. Sloped areas ultimately may develop a patina surface akin to that of pure copper, yet quite clearly different.

- Bronze**  
 An alloy of copper and tin. The original warm reddish-brown surface develops in a distinctive manner through weathering. A brown-red surface oxidation with a brown-grey undertone is typical for this alloy; the material then gradually changes to dark brown anthracite throughout - the subsequent patina coating forms much more slowly than with pure copper.

- Golden Alloy**  
 This golden material is an alloy of copper with aluminium and zinc, which is very stable and keeps its golden shade over time. It behaves differently to pure copper in the environment as it has a thin protective oxide layer containing all three alloy elements when produced. As a result, the surface retains its golden colour indefinitely and simply loses some of its sheen as the oxide layer thickens with exposure to the elements, giving a matt gold coloured appearance.

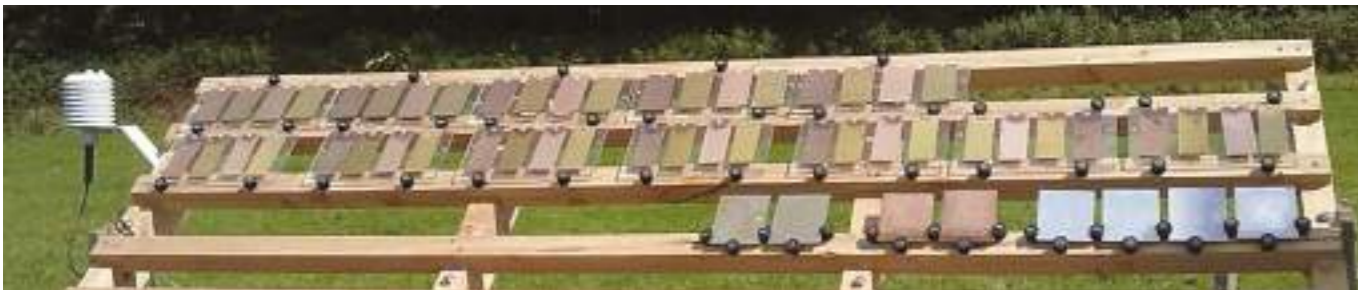
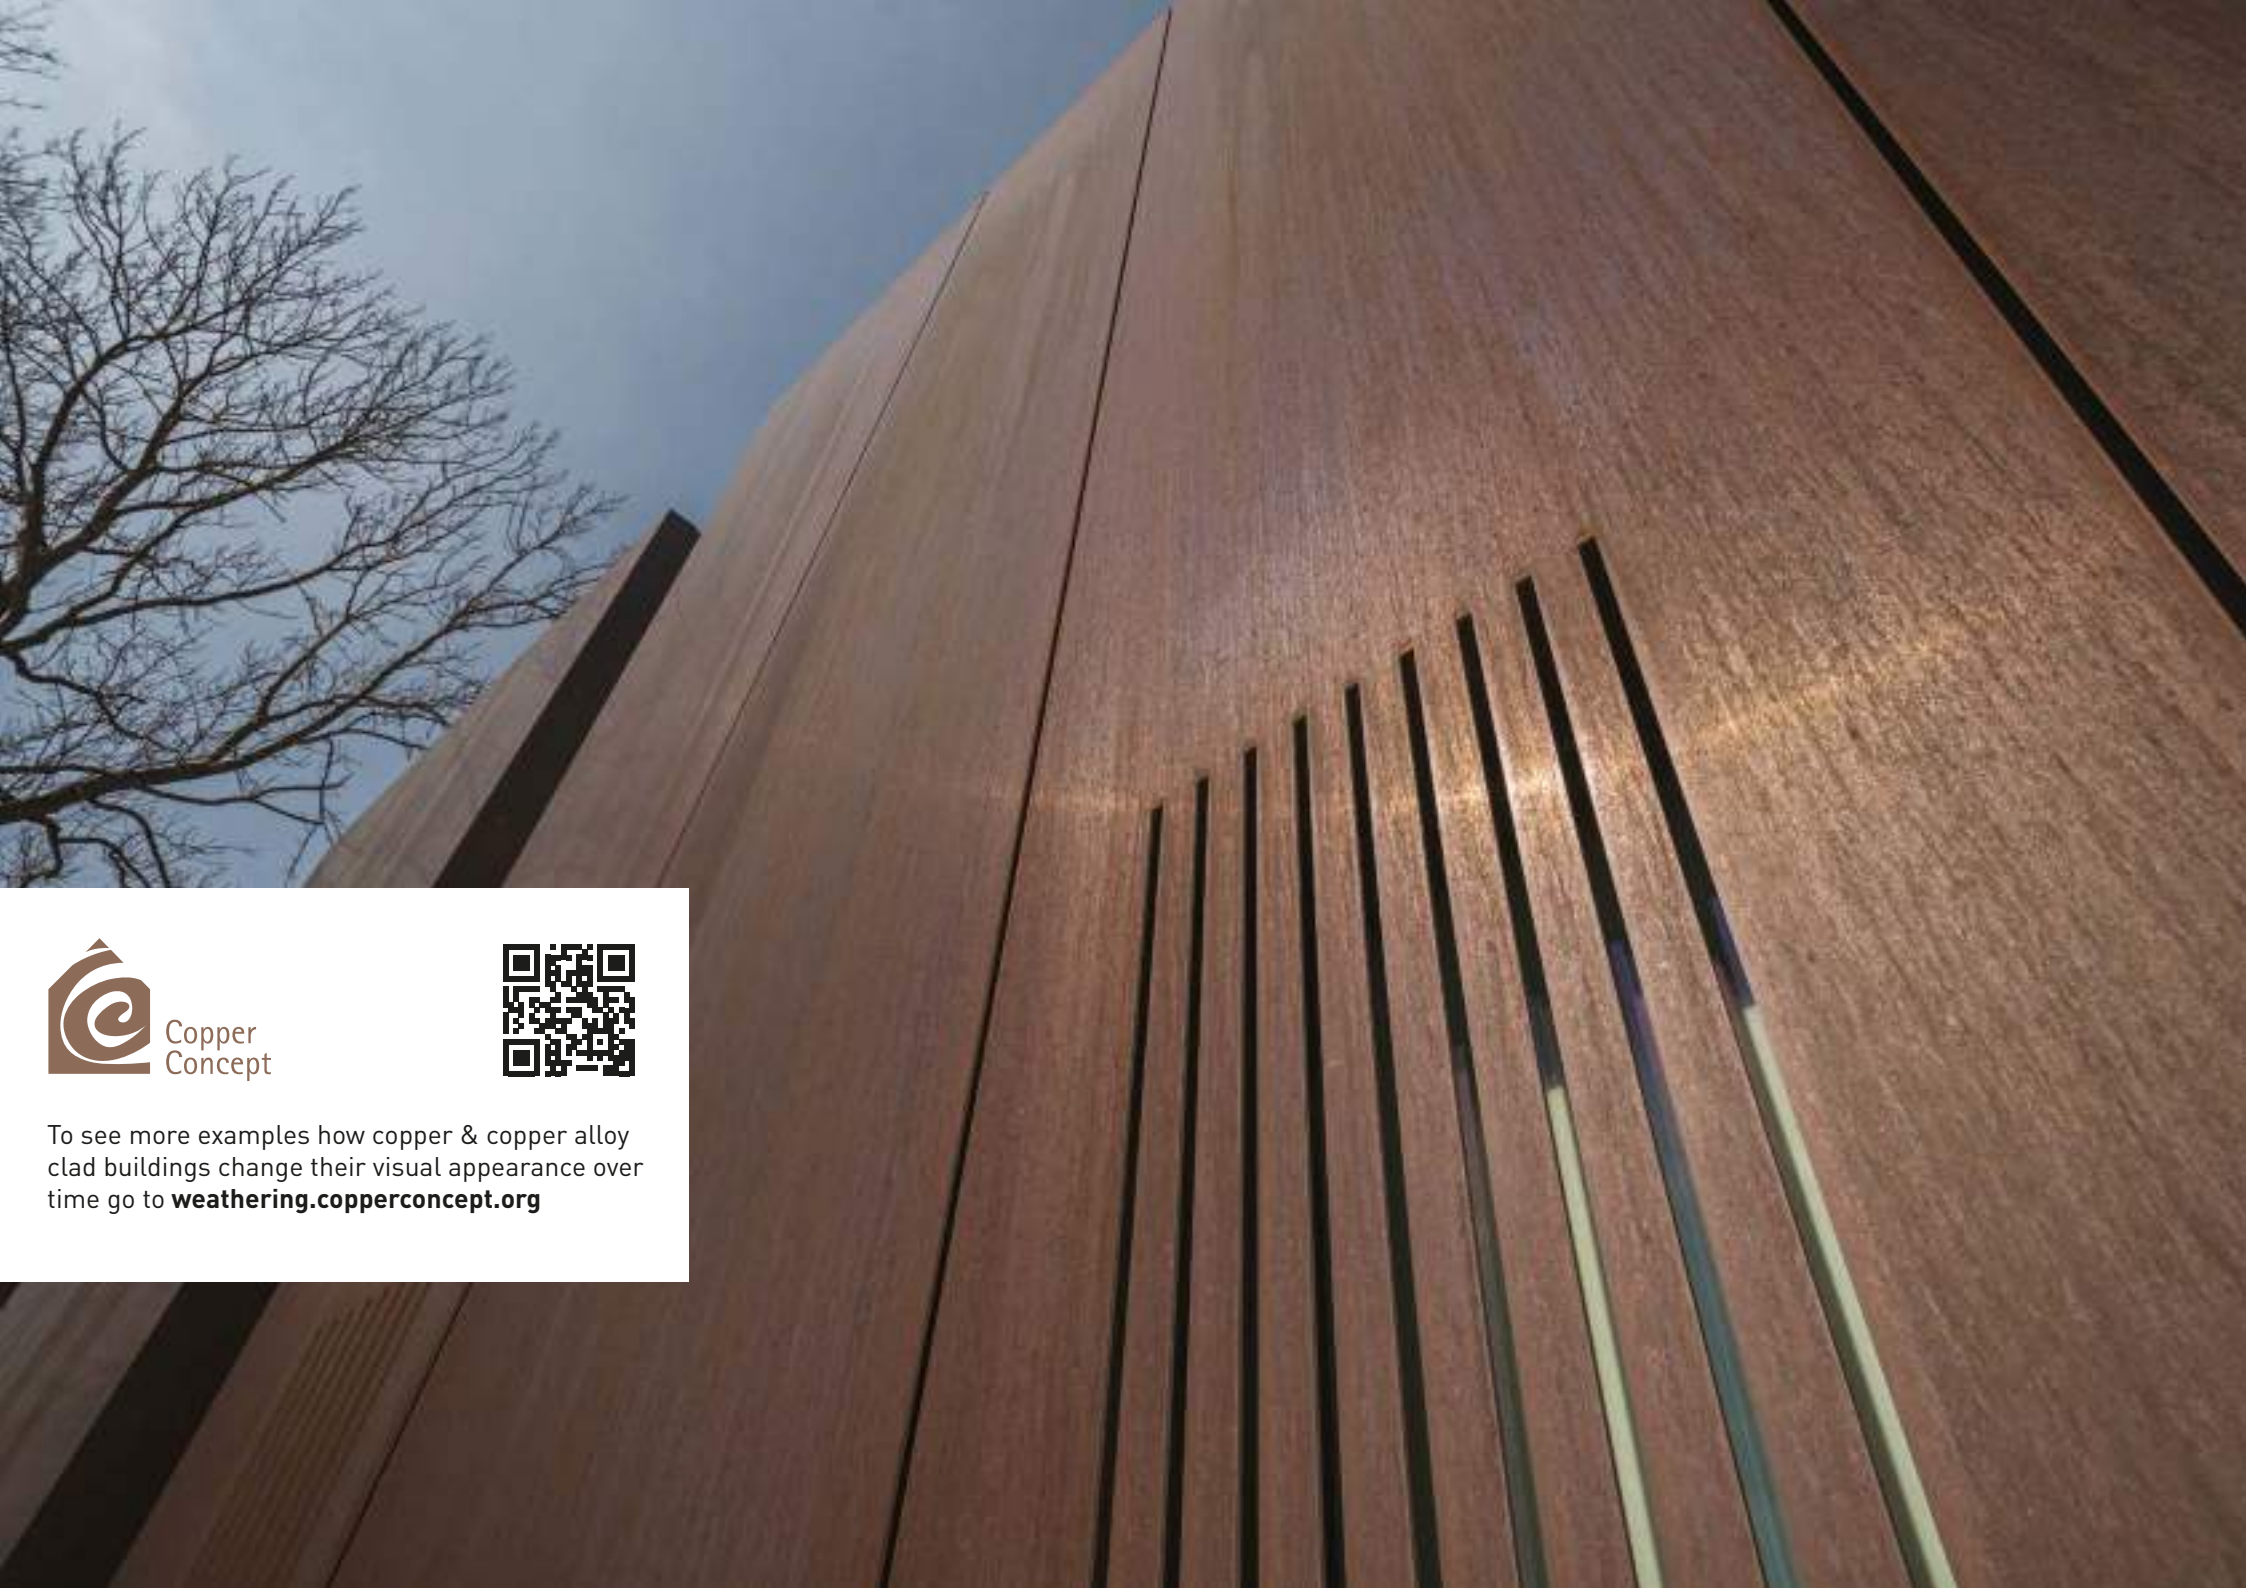
Selected pictograms from the KTH study show changes in surface appearance after 6 months, three and five years in different locations exposed at inclinations relevant for roofing (45 degrees) and facades (90 degrees) for four different copper based materials: Natural Copper, Brass, Bronze and Golden alloy.

- **Marine:** Exposure site St Anne, 25m distance from sea shore, high corrosivity level environment
- **Inland:** Exposure site Langonnet, 40km distance from sea shore, moderate corrosivity level environment

The way the protective patina forms, its thickness and composition largely influence the visual appearance of the material. Scientific results confirm that the level and how rapid the surface appearance change depend primarily on:

- **air quality & weather conditions:** the concentration of air pollutants, deposition of particles and prevailing weather conditions largely influence the patina composition,
- **distance from the sea:** (materials close to marine splash areas will develop a green hue quite quickly, whereas materials placed in urban environments may tend towards a dark brown hue),
- **alloy composition,**
- **surface inclination and orientation.**
